**A Corrosion Analysis
of
Aluminum Alloys and Coatings**

Prepared by David Barth
BetaLED

May 2008

An analysis of aluminum alloys and coatings to determine a reasonable resolution to aluminum die cast corrosion that is also cost efficient and environmentally friendly.

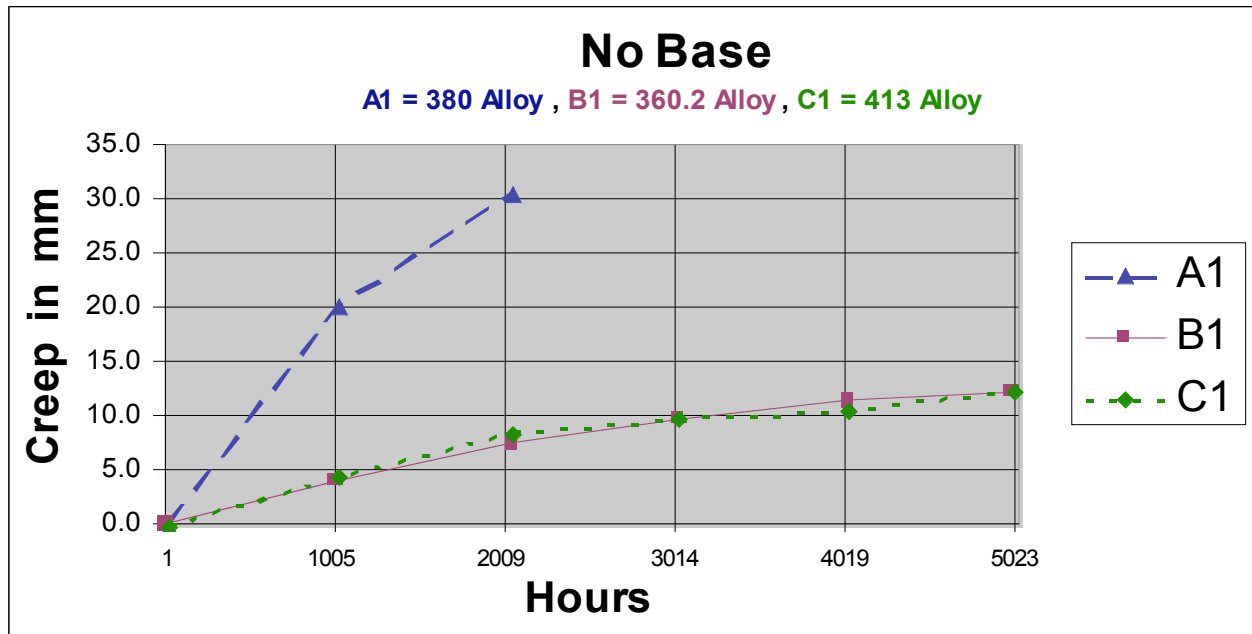
Graph 1 – Compares all three aluminum alloys with powder paint top coat only.

Table 2 below provides the statistical analysis for each type of alloy/coating combination, using data from all 90 samples, at the completion of 5,016 hours in a salt fog chamber.

Creep	A1	B1	C1	A2	B2	C2
Average in MM	*	12.2	12.4	14.5	7.7	5.8
ASTM Rating	(0)	(2)	(2)	(1)	(3)	(4)
Range	*	25	22	22	20	4
Standard Deviation	*	6.94	6.91	6.06	5.09	1.32
95% Conf. Level	*	3.84	3.82	3.35	2.82	0.73

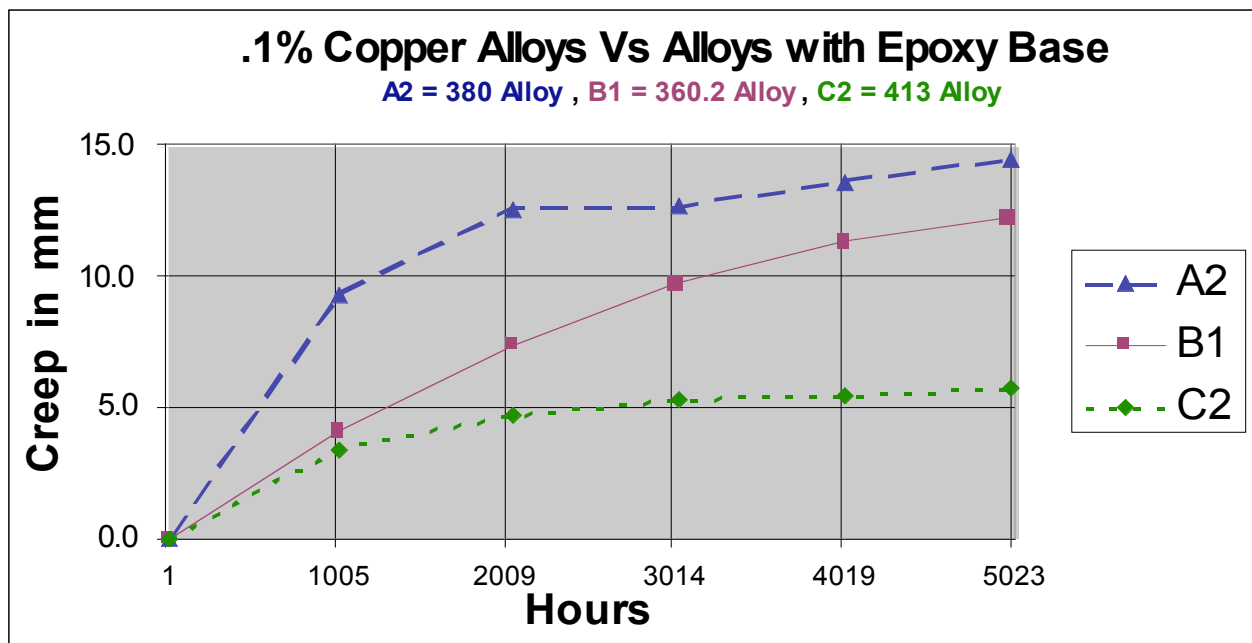
Graph 2 – Compares the aluminum alloy that meets the LM6 .1% copper requirement (B1), to the higher copper content alloys with Epoxy Base coat added (A2 & C2).

Table 3 above ranks sample C2, an alloy having a copper content greater than .1%, significantly higher than the benchmark sample B1. In addition, sample C1 was statistically equal to the benchmark B1. Sample A2 did not fair as well as the benchmark B1, but it did survive the 5,016 hours of salt fog with an ASTM rating of 1.

While the .1% copper content alloys clearly outperform the 3-4% copper content alloy with no base coat applied, the results are just as clear that the copper content of an aluminum alloy should not be the only deciding factor concerning corrosion resistance. There is a high degree of confidence that using a low (.3-.4%) copper alloy, such as 413 or an equivalent 360, with an epoxy base coat applied under a powder top coat, will protect against corrosion as well or better than the minimum requirement of using an alloy with .1% copper. It is also very clear that the samples with the Epoxy base coat were more consistent in the extent of corrosion exhibited, especially sample C2. The least amount of consistency was seen on the .1% copper baseline example B1, as evidenced by the Range, Standard Deviation, and 95% Confidence Level numbers documented in table 2.

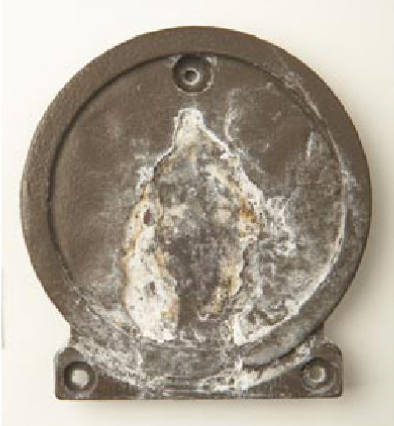
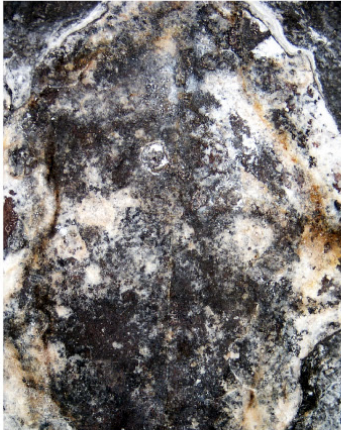
Section 5: Pictures (After 5016 hours of salt fog testing)

Magnification 3.4 Diameters

*The A1 reading for creep was 16.9 (0) after 792 hours, and it experienced paint/coating failure over 75% of its surface after 2,352 hours. A1 test readings were stopped after both measurements reached a Zero (0) rating.

**A1 reading for creep was 16.9 MM after only 792 hours. By 5,000 hours nearly the entire surface of the sample was experiencing some level of corrosion.

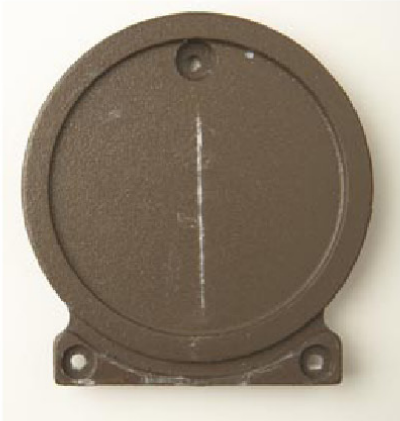
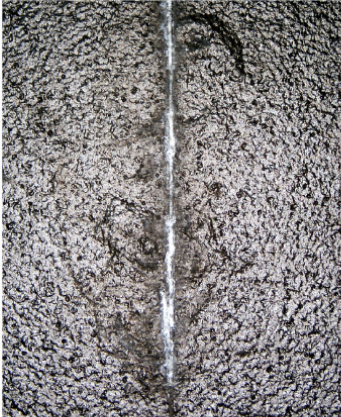
B1

Magnification 3.4 Diameters

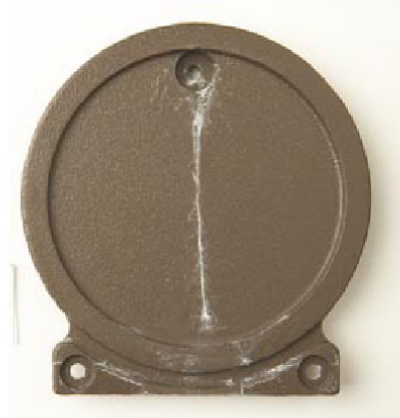
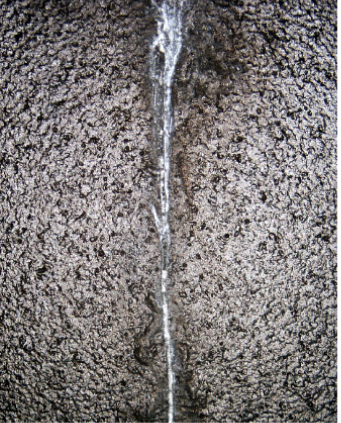
C1

Magnification 3.4 Diameters

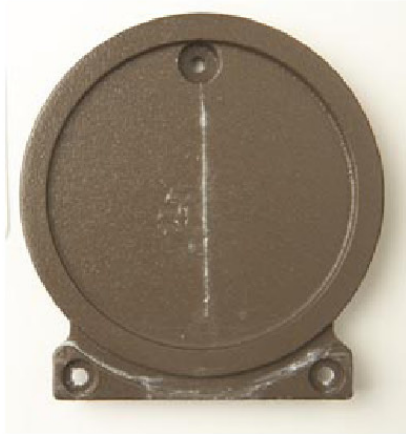
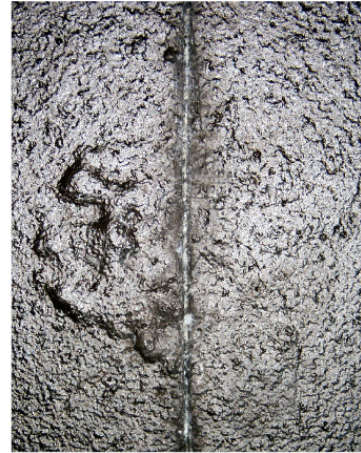
A2

Magnification 3.4 Diameters

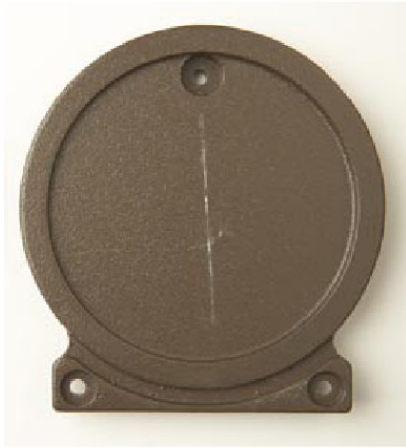
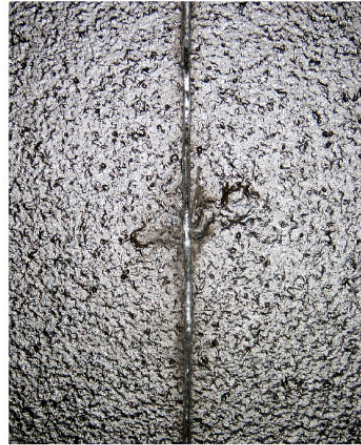
B2

Magnification 3.4 Diameters

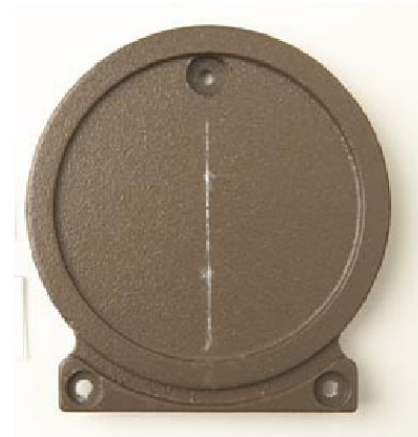
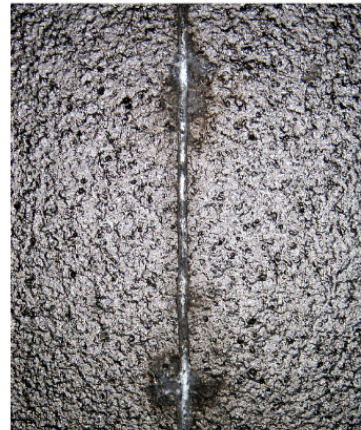
C2

Magnification 3.4 Diameters
