NO: IGSB 261

## Infrastructure Group Safety Bulletin

### The purchase, issue and use of the Seaward Live Line Tester (LLT) and Proving Unit for DC Lines.

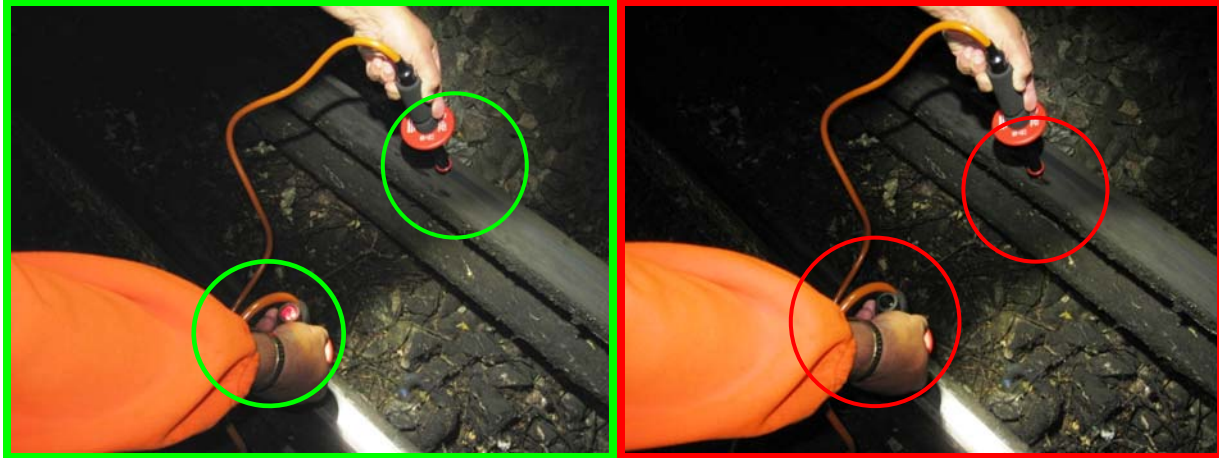
- The following photographs show what difference this can make to the indication given by the LED by testing with the probe on a clean uncontaminated section of rail head even within a few centimetres at the same site....

Clean head on the right and illuminated LED on the left.

Contaminated head on the right and no illuminated LED on the left.

1. All staff who use this item of equipment must be briefed the following;
  - The Seaward LLT unit must be tested with the proving unit **immediately prior to and after use**. This is an integral part of the process and the only method of confirming the LLT is working at the time of use.
  - When applying the LLT probes to the conductor and running rail, a clean section of rail head should be identified. If there is any suggestion the rail head is not clean then apply pressure and use a scratching motion to make sure of the connection. Never apply the LLT on a ramp end.

- VII. If the LED indicator on the handle of the LLT is not illuminated, check the rail head for contamination, and move the contact point or carry out the scratching motion then the rail is switched off or isolated.
